# Hospital Generator Fuel Polishing

## Case Study

### **Problem:** Hospital Needed Generator Fuel Polishing Across Multiple Storage Tanks

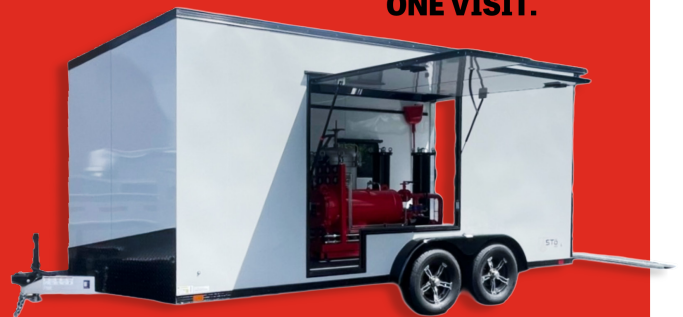
TANK 1

TANK 2

TANK 3

PFP was able to quickly mobilize a trailer-mounted mobile fuel polishing system, allowing for multiple generator fuel tanks to be polished in a single day. This approach to fuel polishing drastically reduces downtime while simplifying on-site service.
